Shellhold Pty Ltd

INSECT SCREENS TESTED TO THE AUSTRALIAN STANDARD

10 February 2004
J062133

NEUTRAL SALT SPRAY TEST REPORT

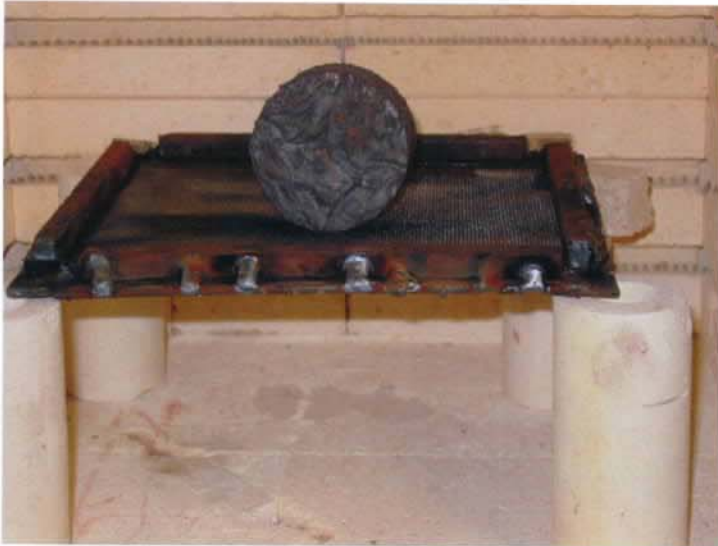
Fig.1: Stainless steel mesh sample in frame with 665g load in furnace prior to test.

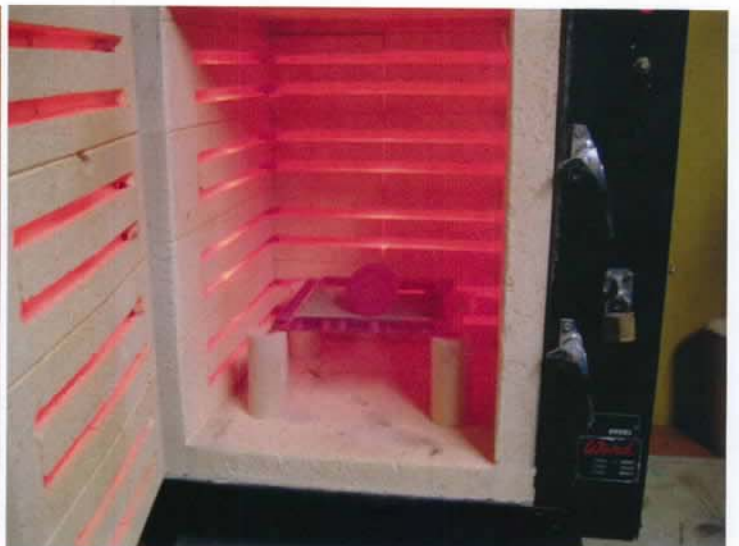
Fig.2: Stainless steel sample at 800 degrees Celsius.

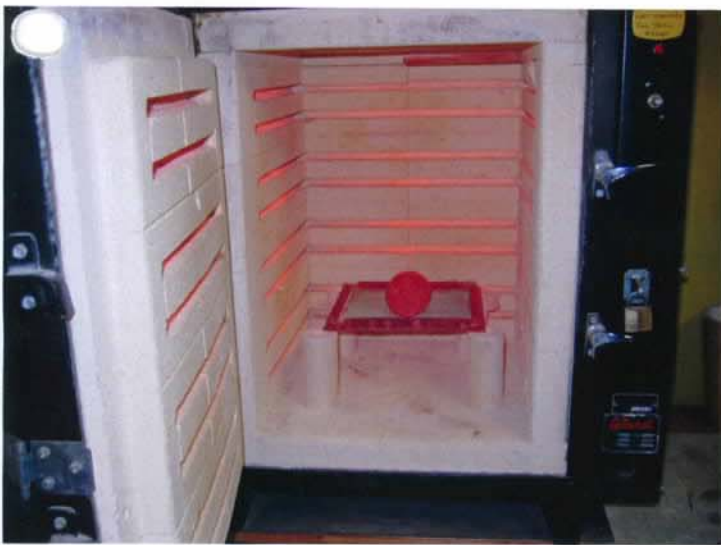
Fig.3: Stainless steel sample at 850 degrees Celsius.

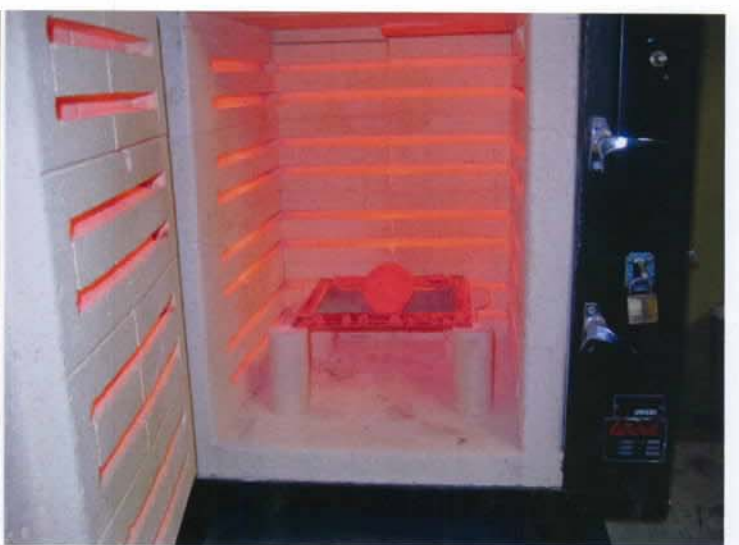
Fig.4: Stainless steel sample at 900 degrees Celsius.

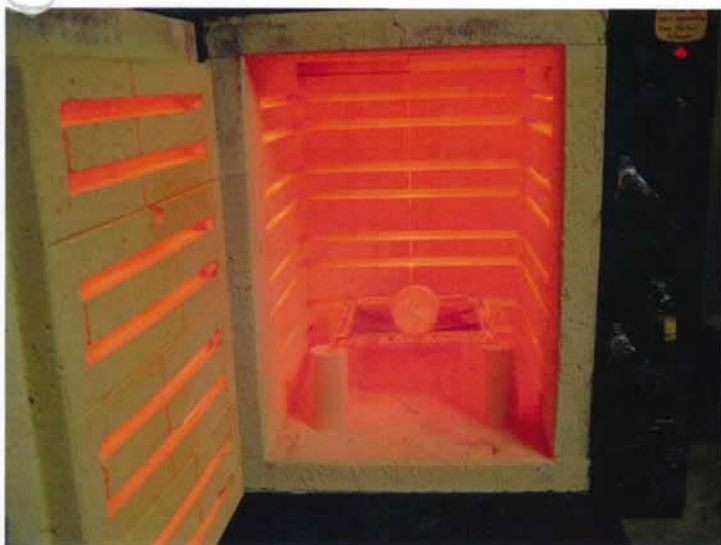
Fig.5: Stainless steel sample at 950 degrees Celsius.

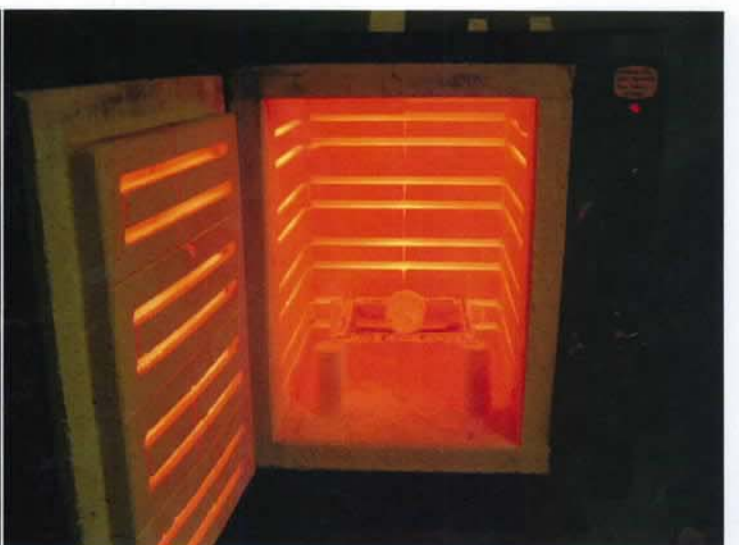
The stainless steel mesh did not fail and was heated to 1000 °C and held for 24 hours, still without failure.

Fig.6: Stainless steel sample at 1000 degrees Celsius.

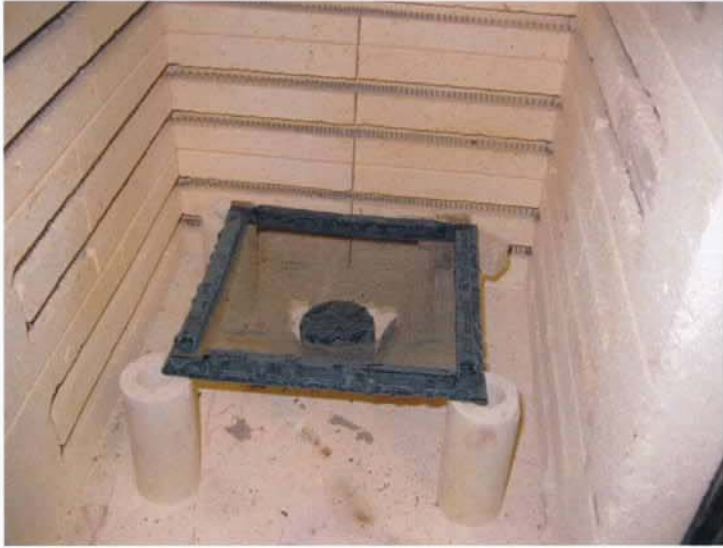
During the cooling of the stainless mesh sample, the sample failed and the steel mass fell through.

Fig 7: Stainless steel sample cool after failure.
